2008-09-18 Pbar Department Meeting

- Downtime, Gap
 - Part 1 - Li Lens failure
 - 10mm-3: 2nd stripline,

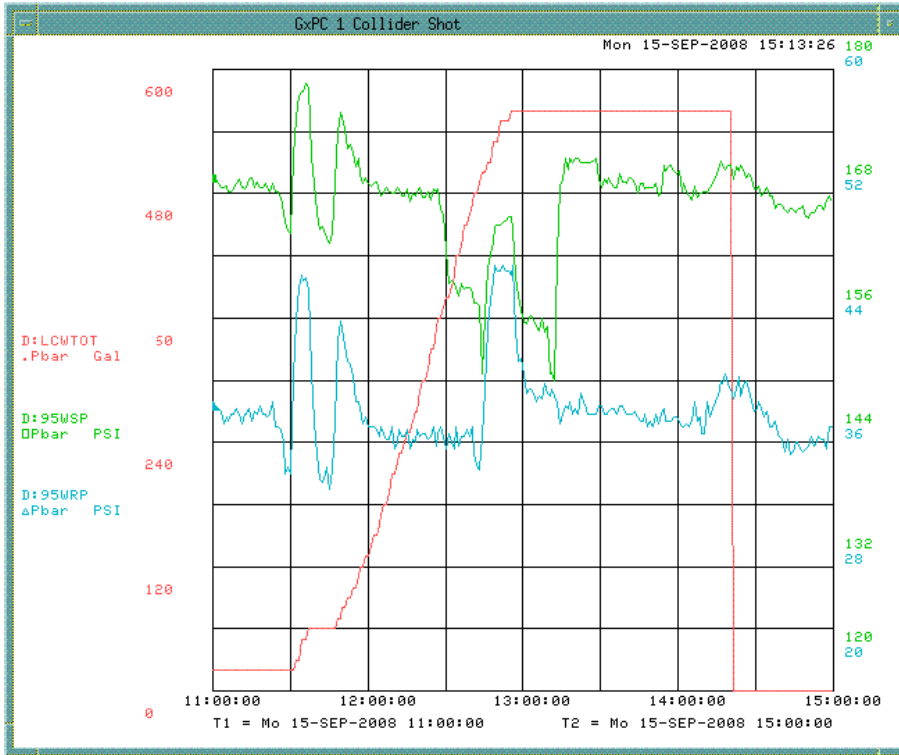
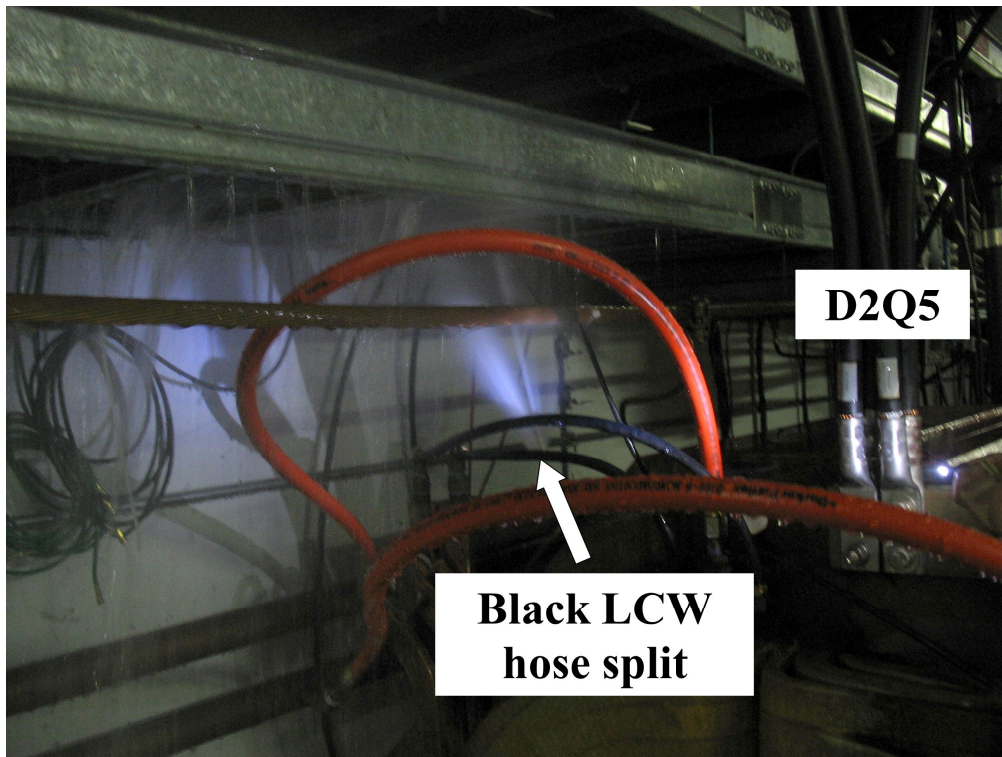
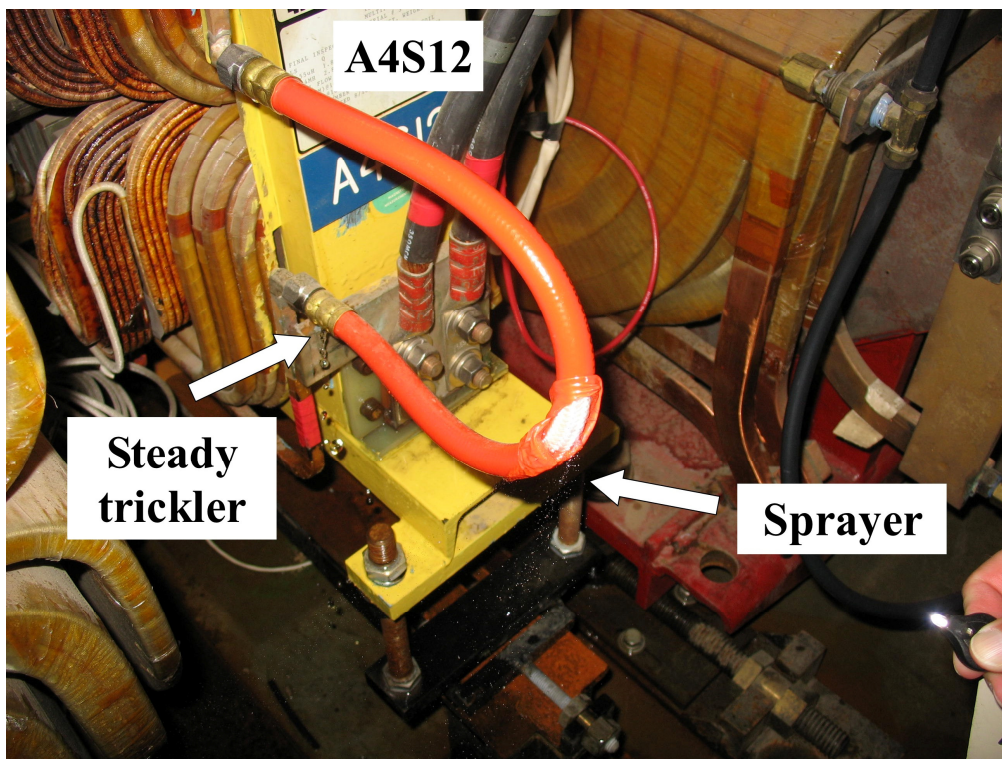
- So Ryan is looking to redesign this fitting.
 - Not certain that this water is the cause of the ground fault.
 - Also had lots of rain, the humidity is high. Condensate drain backs up due to biological growth, making big puddle. - fixed with two quarts of bleach.
 - High humidity may have contributed to failure.
 - Also on picture above, the bolt on the clamp ring is missing (2:00 on the plot in the shaded area).
- 10mm-5 was installed.
 - Part 2: A6Q6 - ground water was dripping on magnet causing ground fault.
- LCW leak
